USDA-FOREST SERVICE

FS-2500-8 (7/08)
Date of Report: 1/16/18

DRAFT THOMAS BURNED AREA REPORT
(Reference FSH 2509.13)

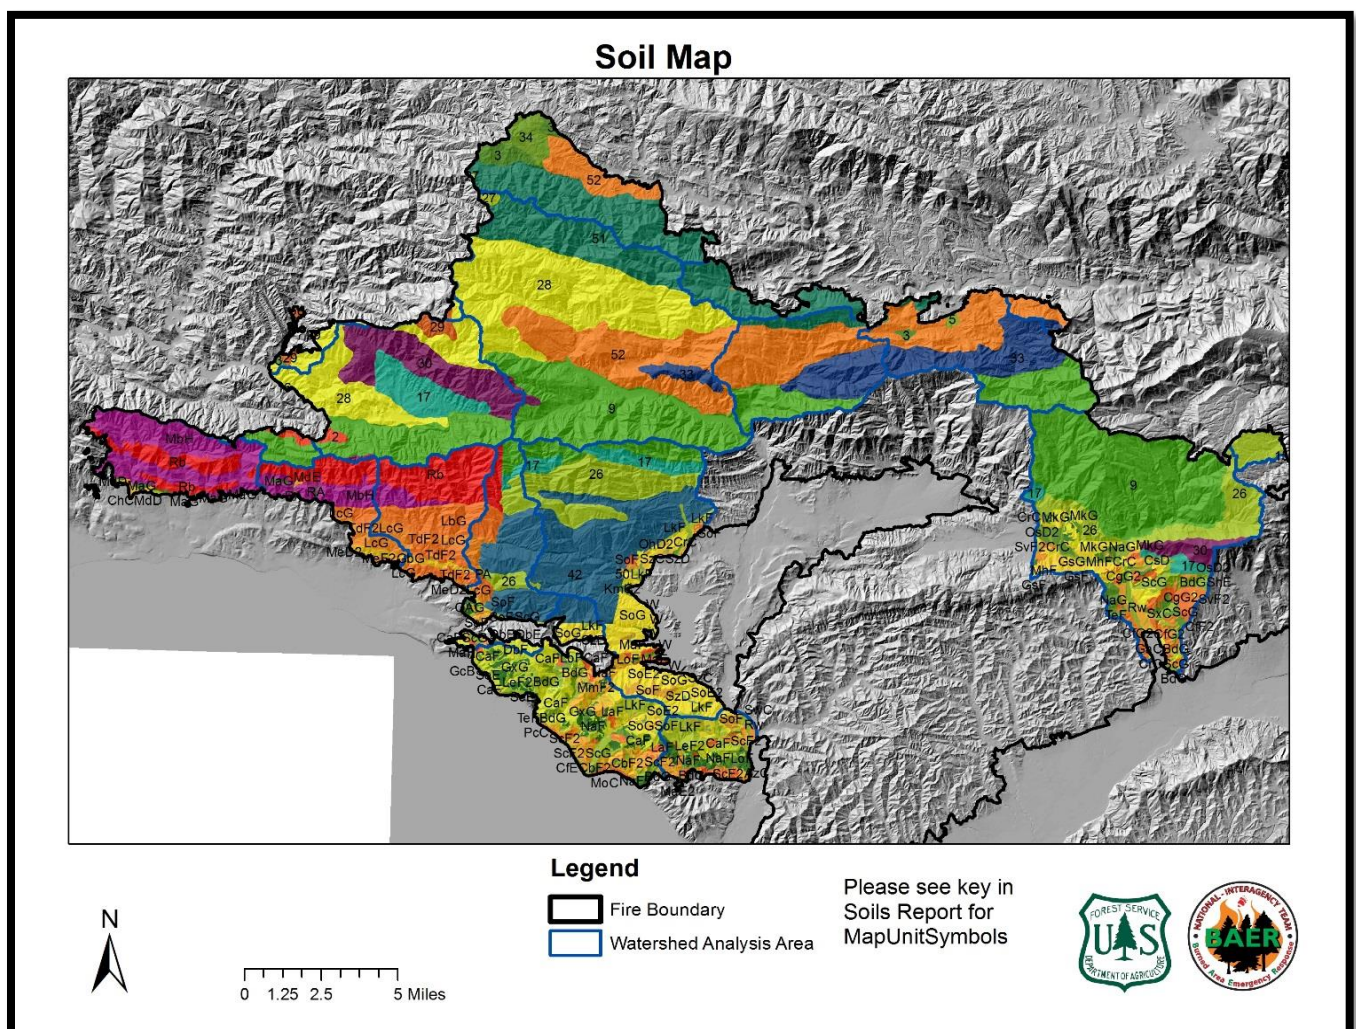
Yorba-Modjeska-Morical families association, range on average from 30 to 60 percent slopes. They consist of a Loam soil texture and covered approximately 17334 acres within the fire perimeter.

Yorba-Millsholm-Stonyford families association, range on average from 30 to 60 percent slopes. They consist of sandy loam soil texture and covered approximately 15348 acres within the fire perimeter (see soils map below).

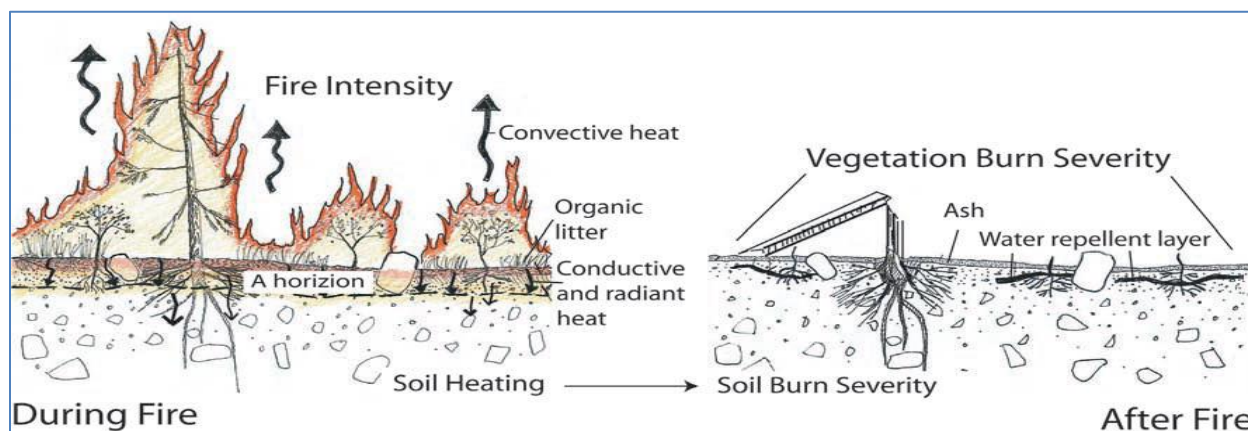
Figure above illustrates the effect of fire intensity on above-ground vegetation and Below ground soil properties (Graphics by Mike Hankinson, National Park Service)

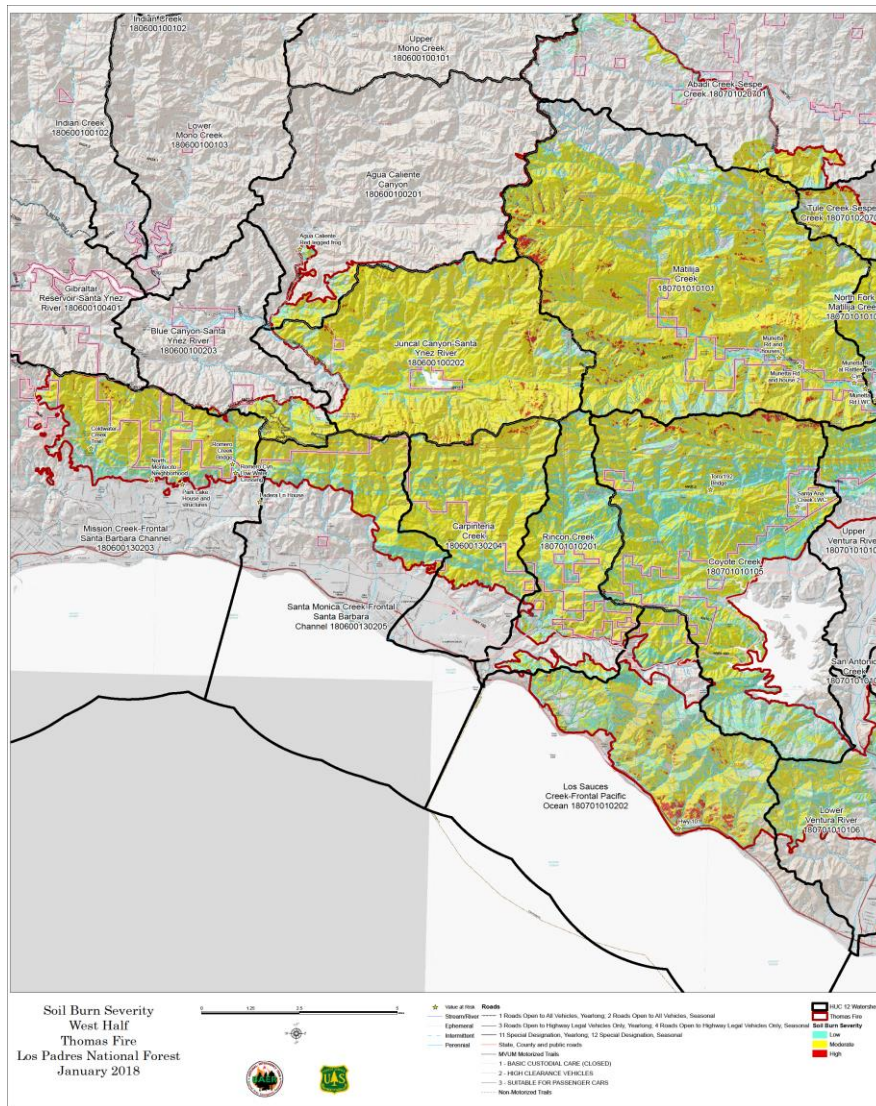
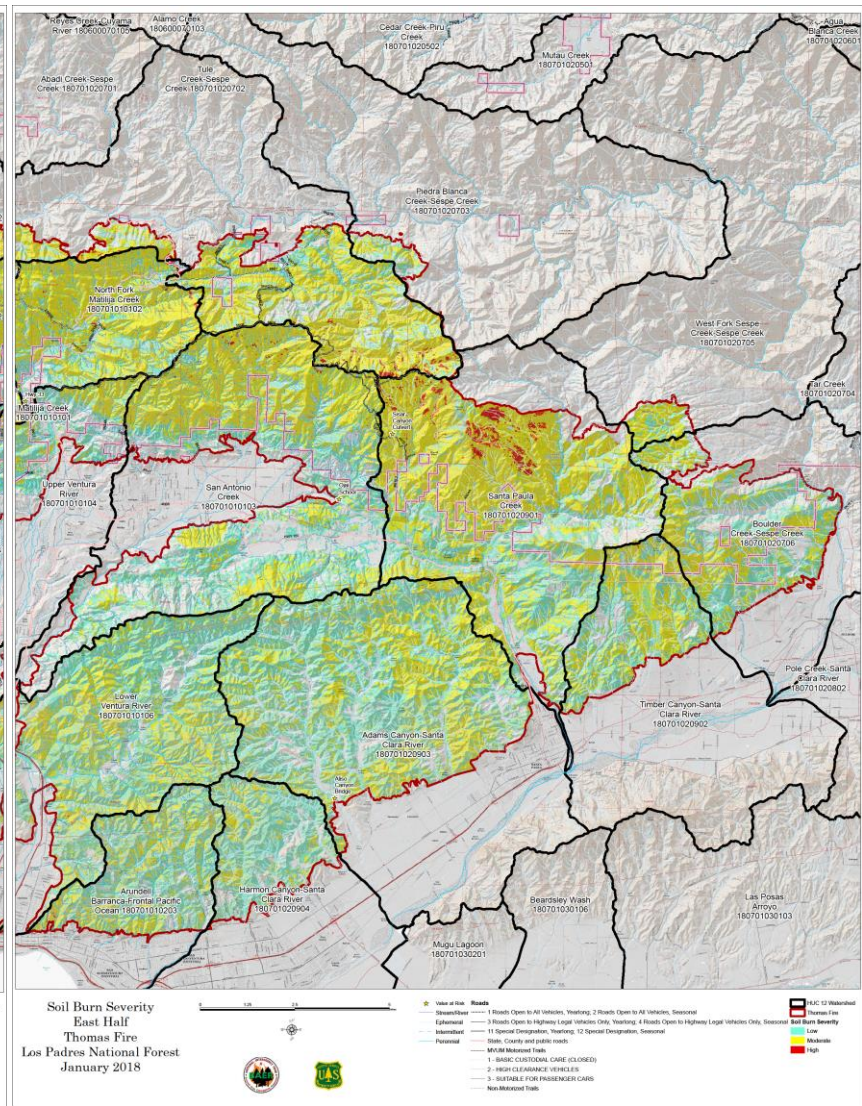
Appendix B: Soil Burn Severity, Sedimentation, Hydrologic Response, and Debris Flow Hazard Maps:
Soil Burn Severity

The following soil burn severity map (Figure 1) illustrates the general soil burn severity pattern on the landscape. The soil burn severity is overwhelmingly moderate (65%) with only a very small amount of high (1%). In most of the moderate burn severity, and some of the high burn severity (particularly on south-facing slopes), there is very little vegetation or ground cover remaining except surface rock. There is 23% low soil burn severity because of the high pre-fire ground cover, and partly because the fire was heavily wind-driven and in deep chaparral that has not burned since 1955. Very low soil burn severity was 10% of the fire area (see Appendix B).
